## ANALYSIS OF JAPANESE NUCLEAR CASUALTY DATA

Final Report  
on  
Contract Nos. OCD-PS-64-196 and N228-(62479)69778  
(Work Unit No. 3411A)

April, 1966

USNRDL-TRC-46

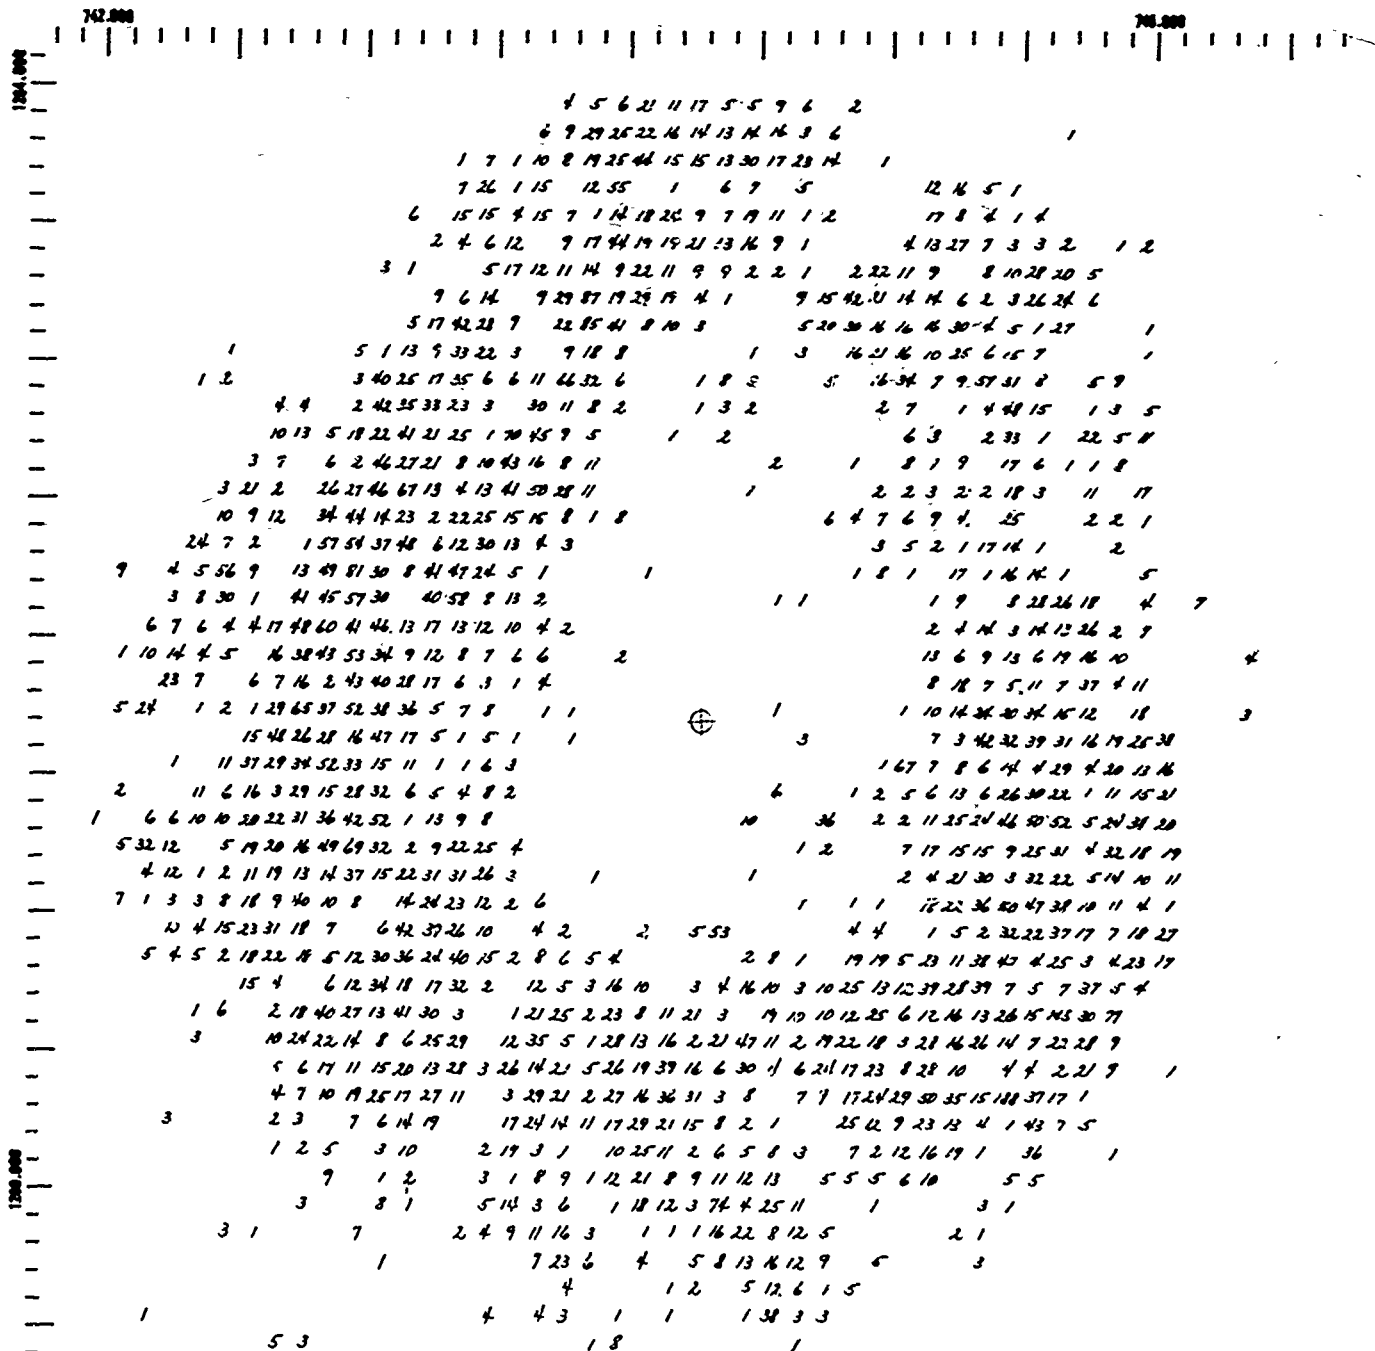
FIG. 3

GEOGRAPHICAL DISTRIBUTION OF DATA FOR HIROSHIMA  
ALL SHIELDING CALCULATIONS

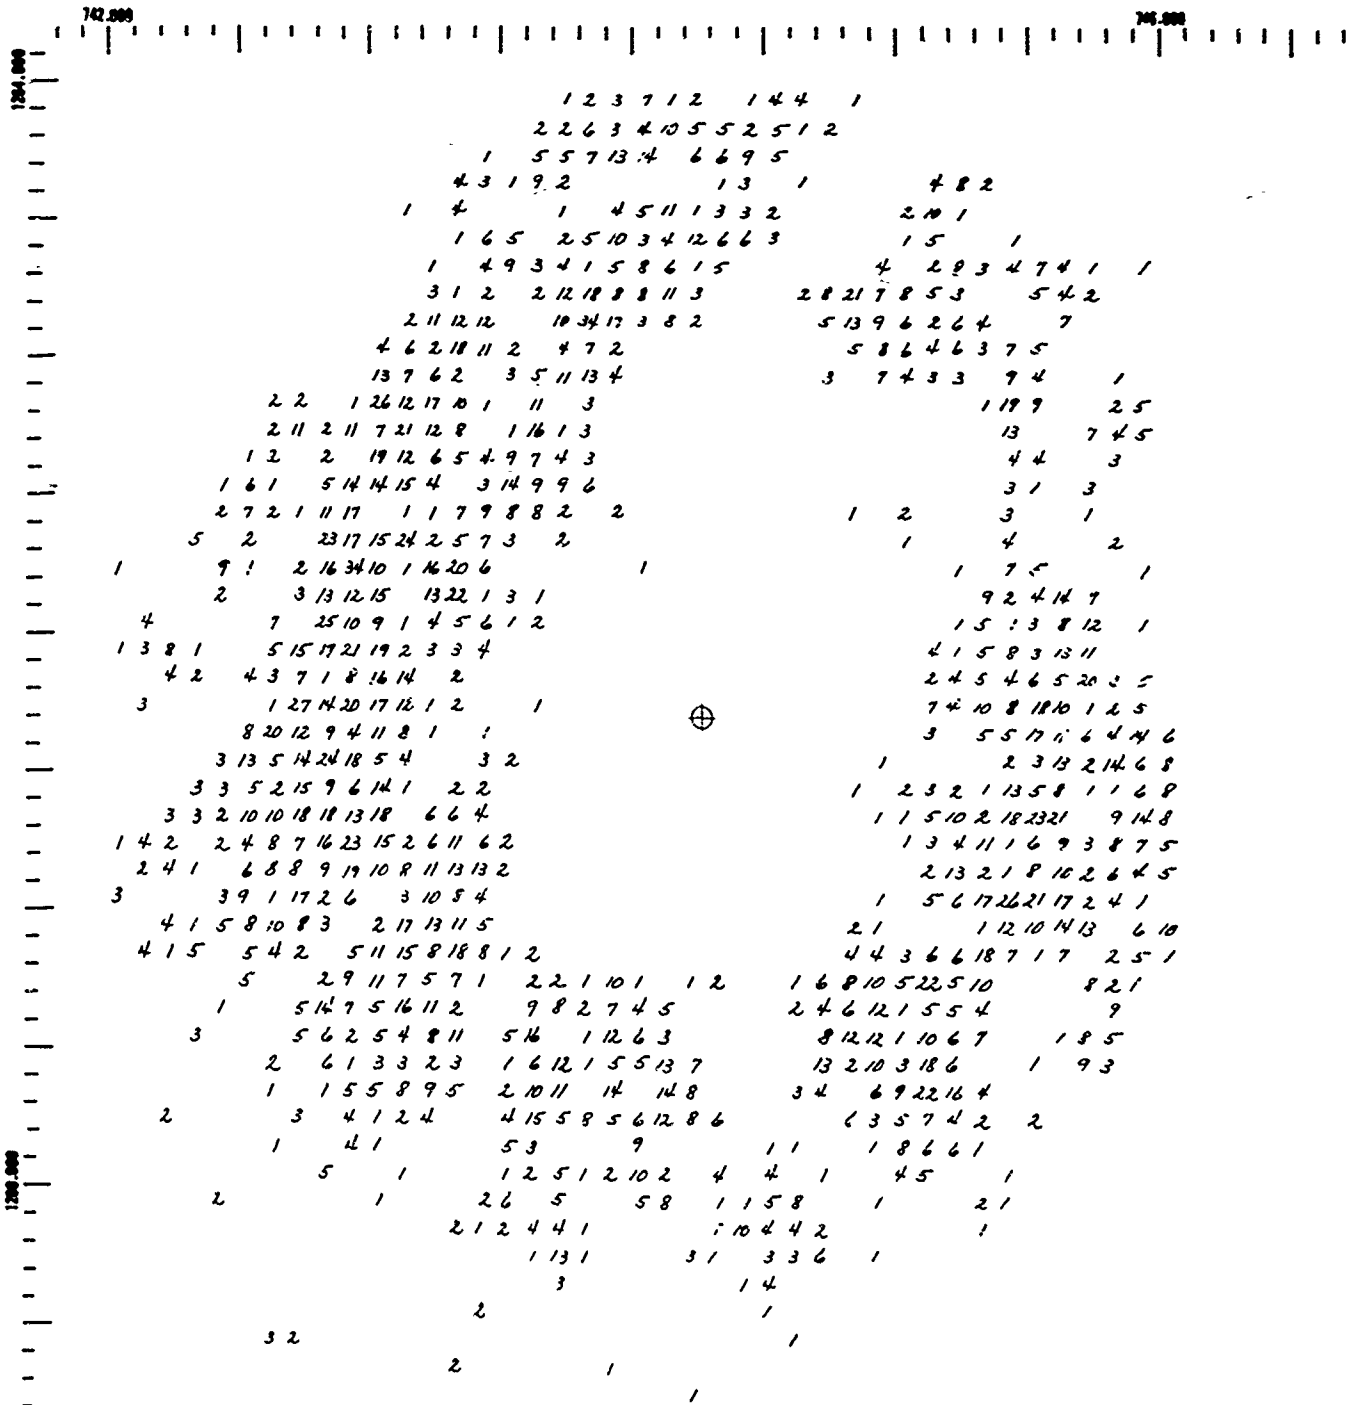
FIG. 21

DISTRIBUTION OF MODERATE BLAST INJURIES FOR HIROSHIMA  
WOOD-FRAME DWELLINGS

Figures 21 through 24 are presented to familiarize the reader with the data distribution on blast and thermal injuries (flash burns) for Hiroshima. The blast injury data are given for wood-frame dwellings, and the burn injury data are given for the outside-unshielded category. These distributions are presented for both moderate and severe injuries. A moderate blast injury is defined to be a single laceration, cut, abrasion, contusion, etc. (excluding minor injuries) or a simple fracture (not of a long bone). A severe blast injury is defined to be multiple lacerations, cuts, abrasions, contusions, etc.; fracture of one or more long bones (simple or compound); compound fracture of other bones; fracture of the skull; or fracture of the spine. A moderate flash burn is defined to be a burn of second degree over less than 10 percent of the skin area, and a severe burn is defined to be a burn of third degree over more than 2 percent of the skin area. (See Table 14 in Appendix A for the detailed criteria for severity of injury.)

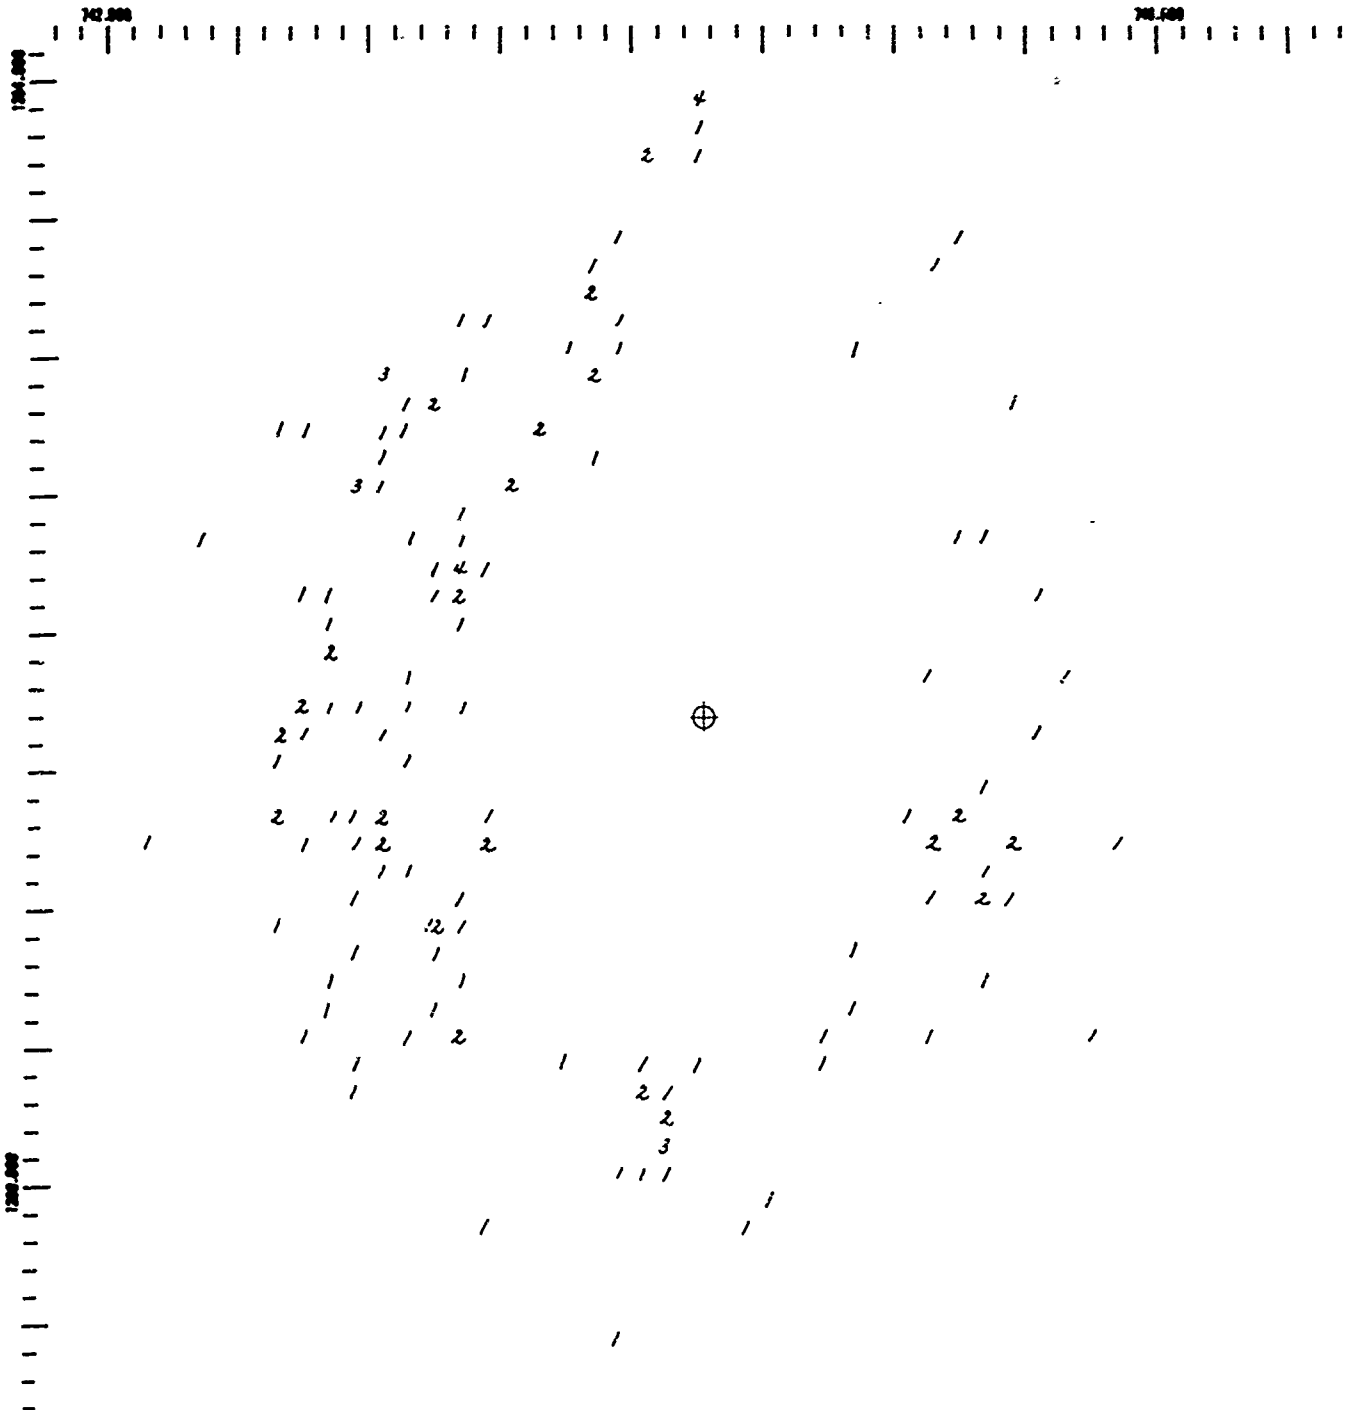
FIG. 22

DISTRIBUTION OF SEVERE BLAST INJURIES FOR HIROSHIMA  
WOOD-FRAME DWELLINGS

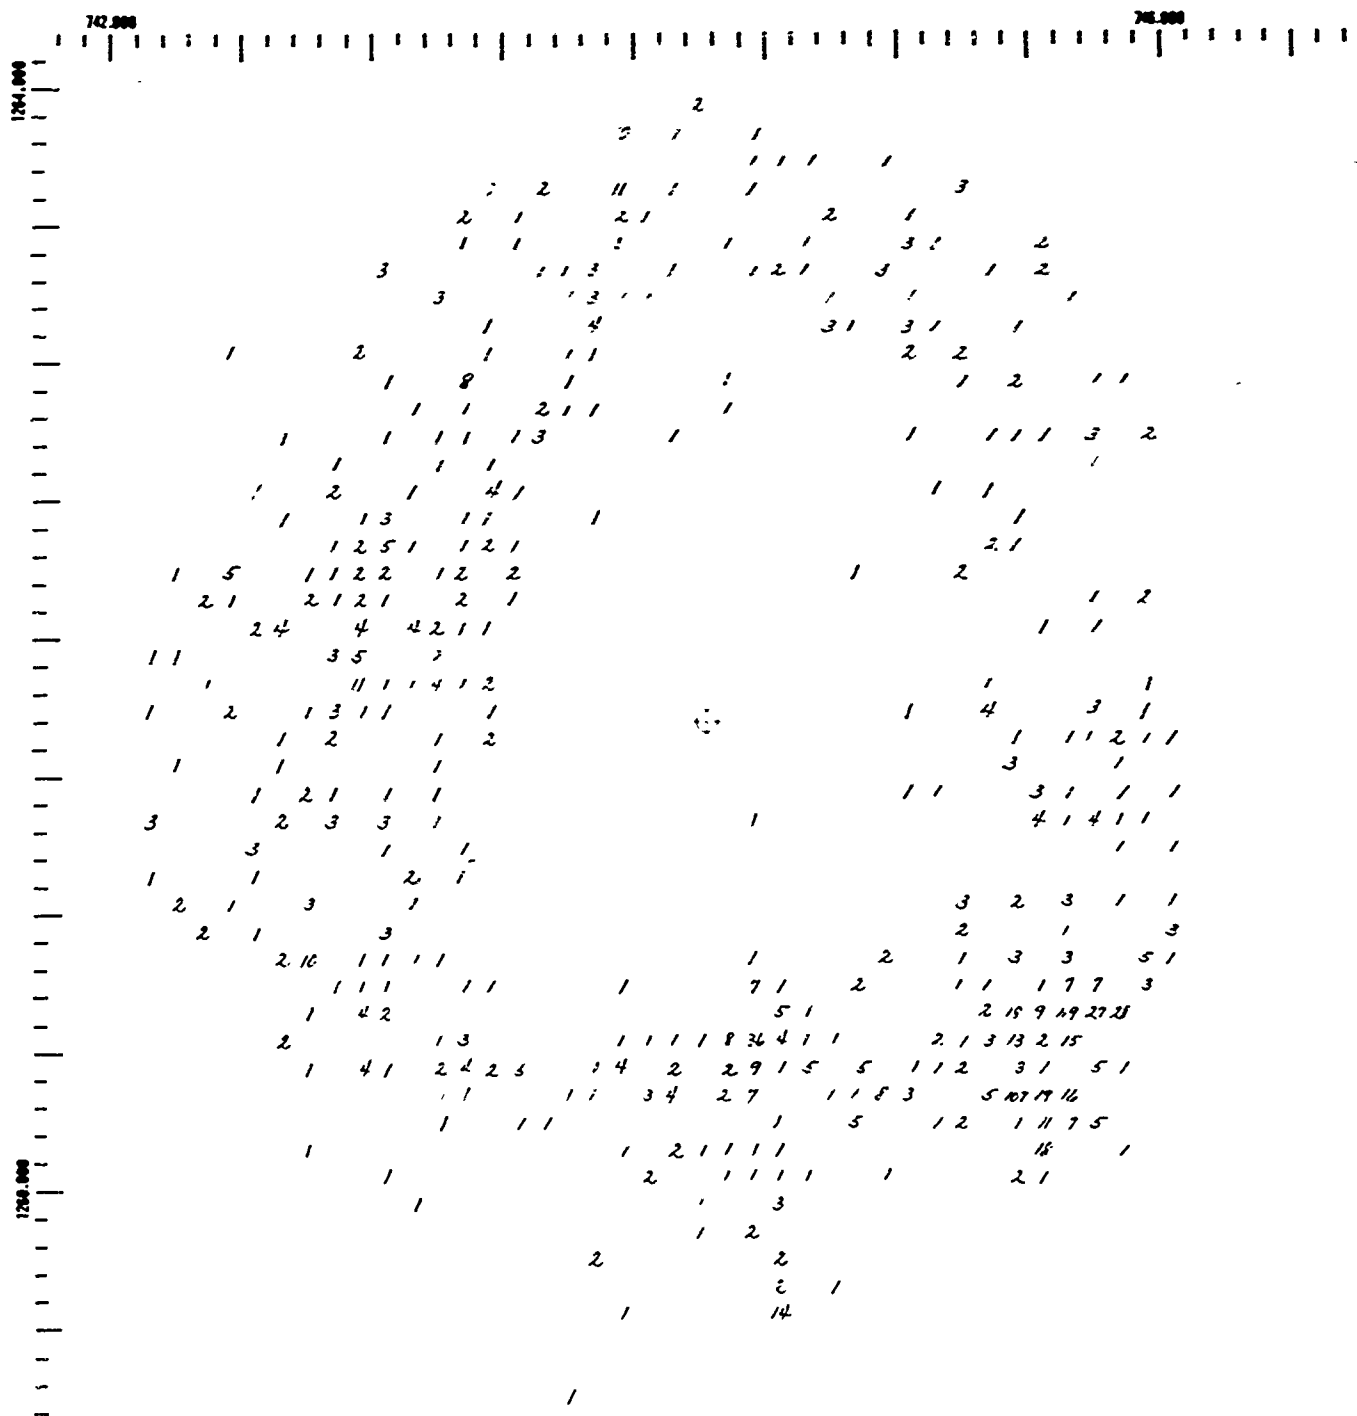
FIG. 23

DISTRIBUTION OF MODERATE FLASH BURNS FOR HIROSHIMA  
OUTSIDE UNSHIELDED

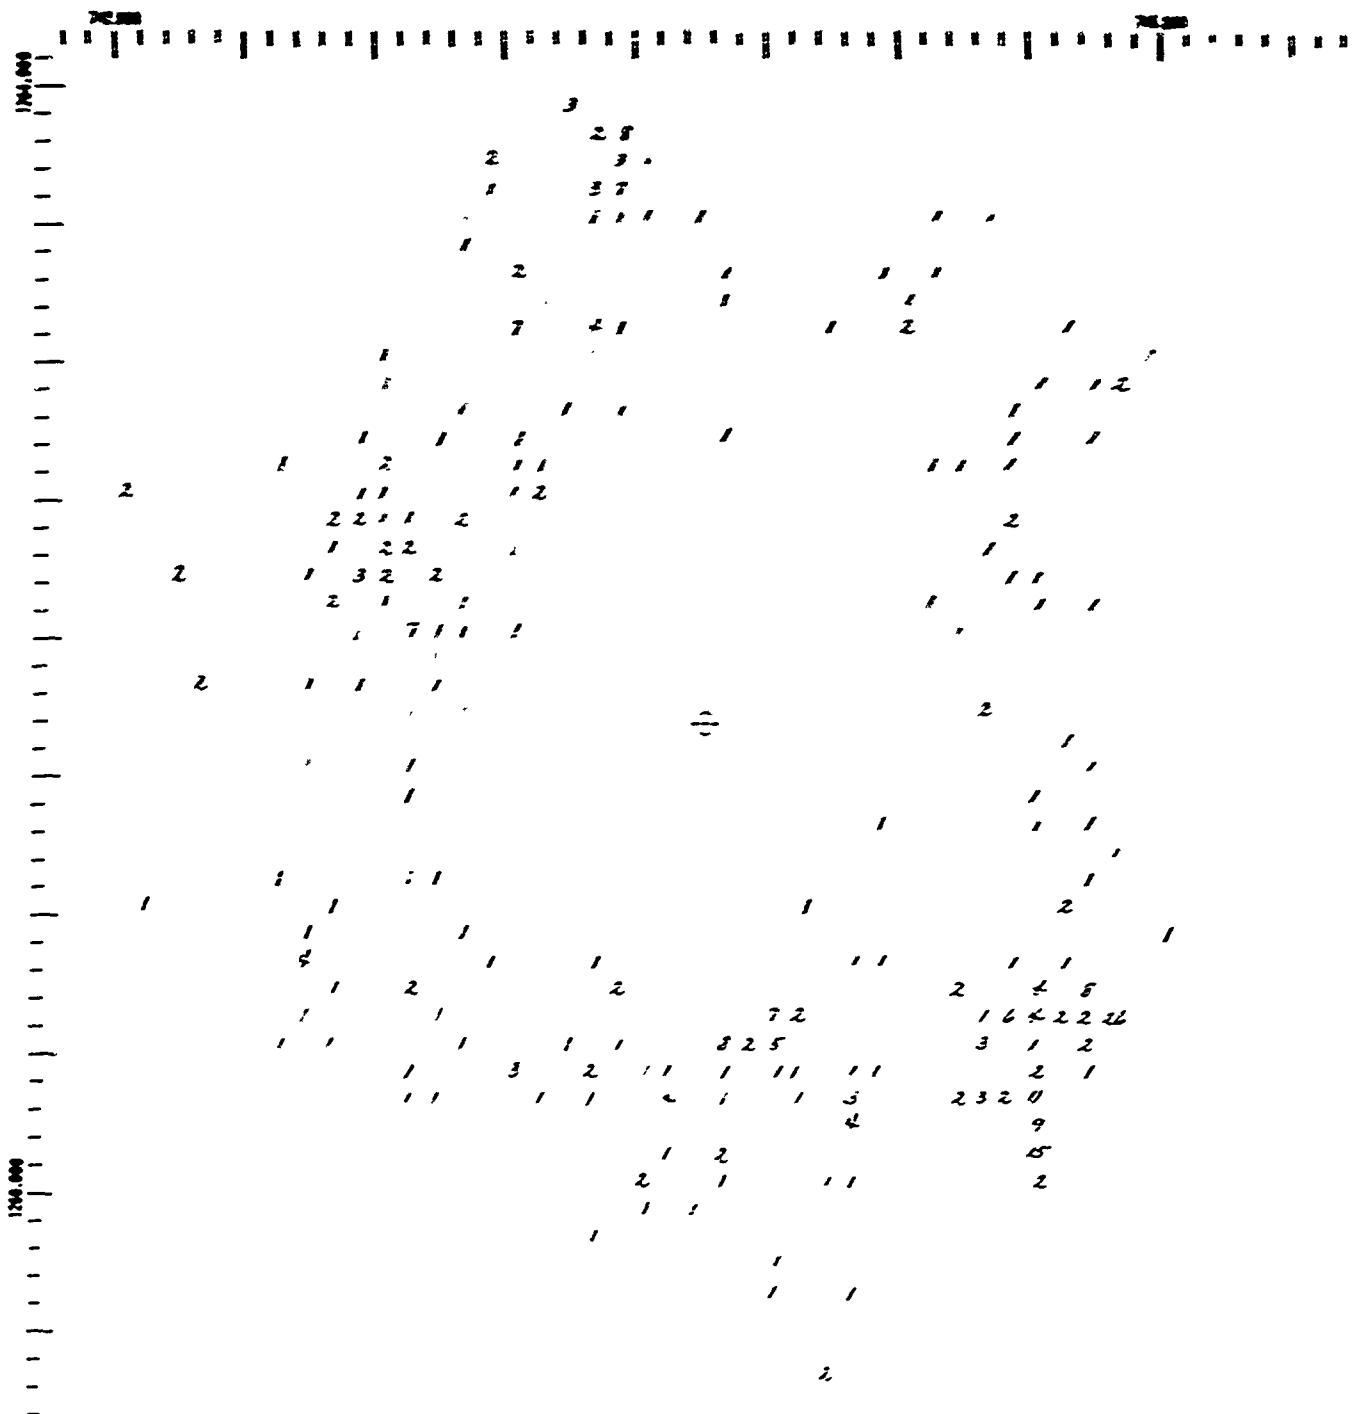
FIG. 24

DISTRIBUTION OF SEVERE FLASH BURNS FOR HIROSHIMA  
OUTSIDE UNSHIELDED

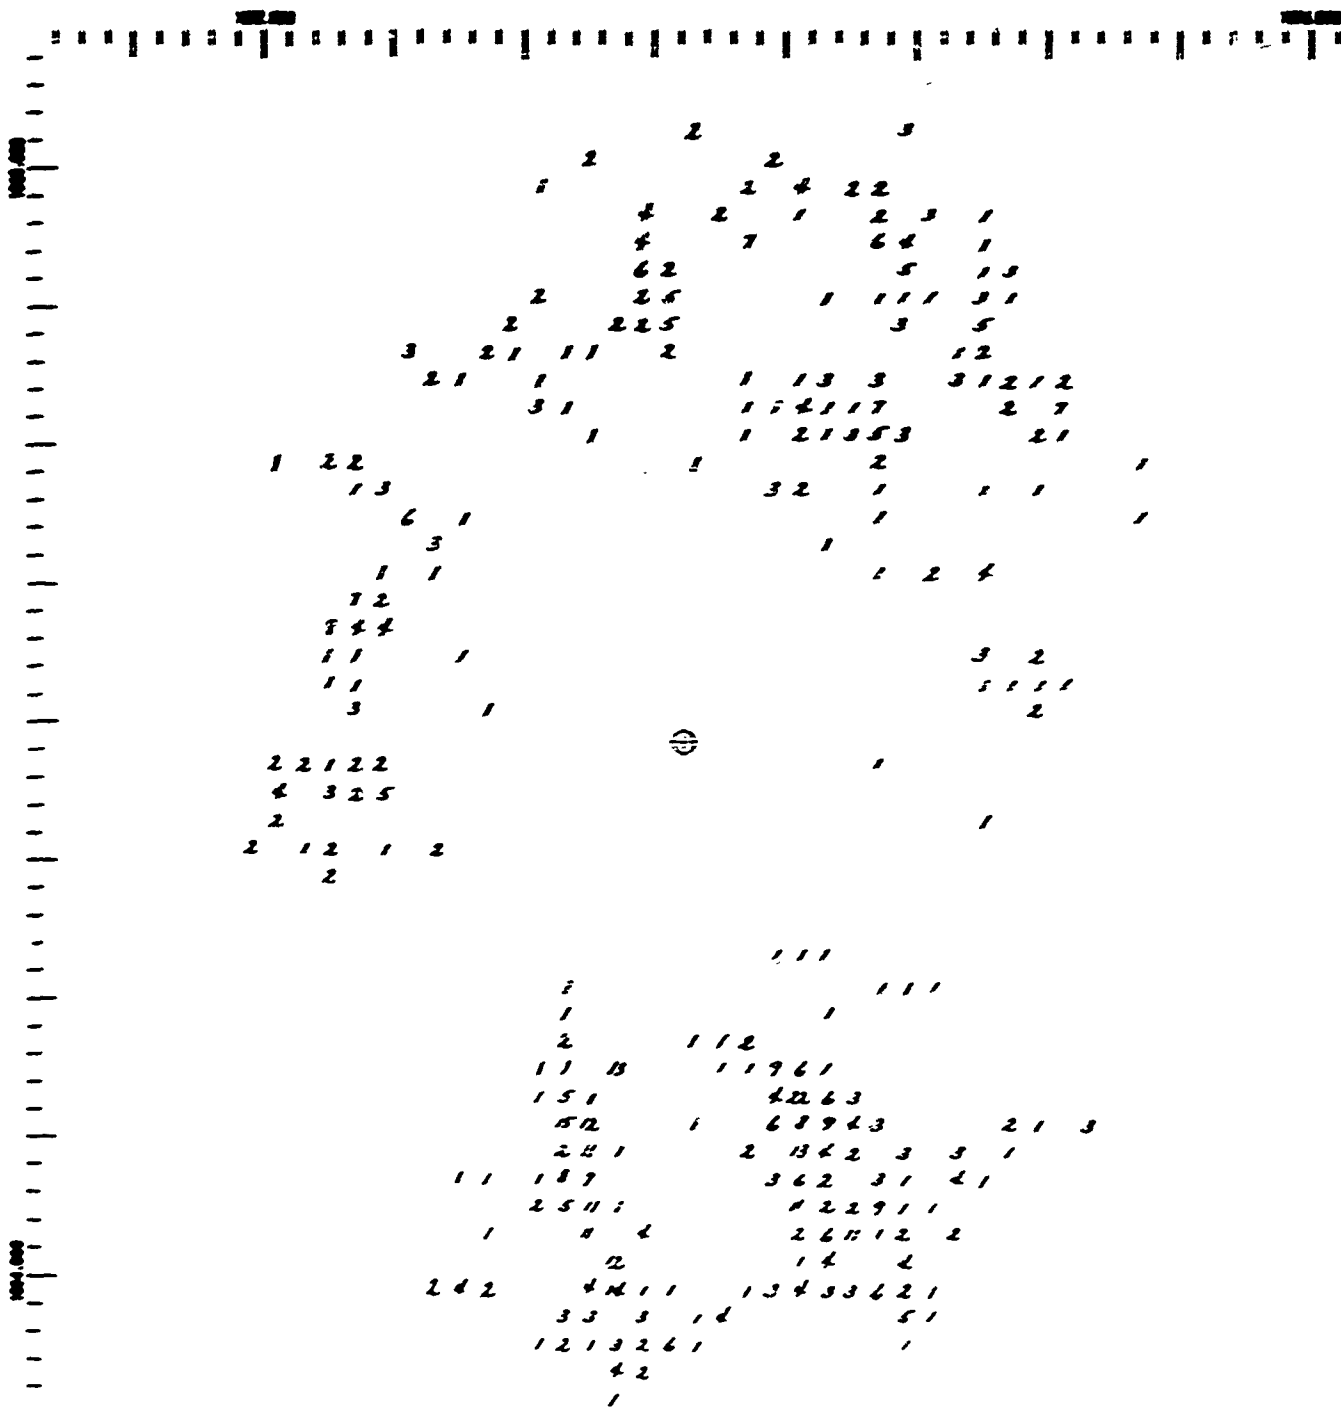
FIG. 25

DISTRIBUTION OF MODERATE BLAST INJURIES FOR NAGASAKI  
WOOD-FRAME DWELLINGS

Figures 25 and 26 present the data distribution for moderate blast and thermal injuries for Nagasaki so that comparisons of the injury distributions between the two cities can be made. Insufficient data for meaningful analysis is the principal reason for the omission of the severe injuries. The rough terrain of Nagasaki affected the distribution of both the blast and the thermal injuries. However, it should be pointed out that almost all of the data came from persons who were not shielded from the burst by the hills running through the city.

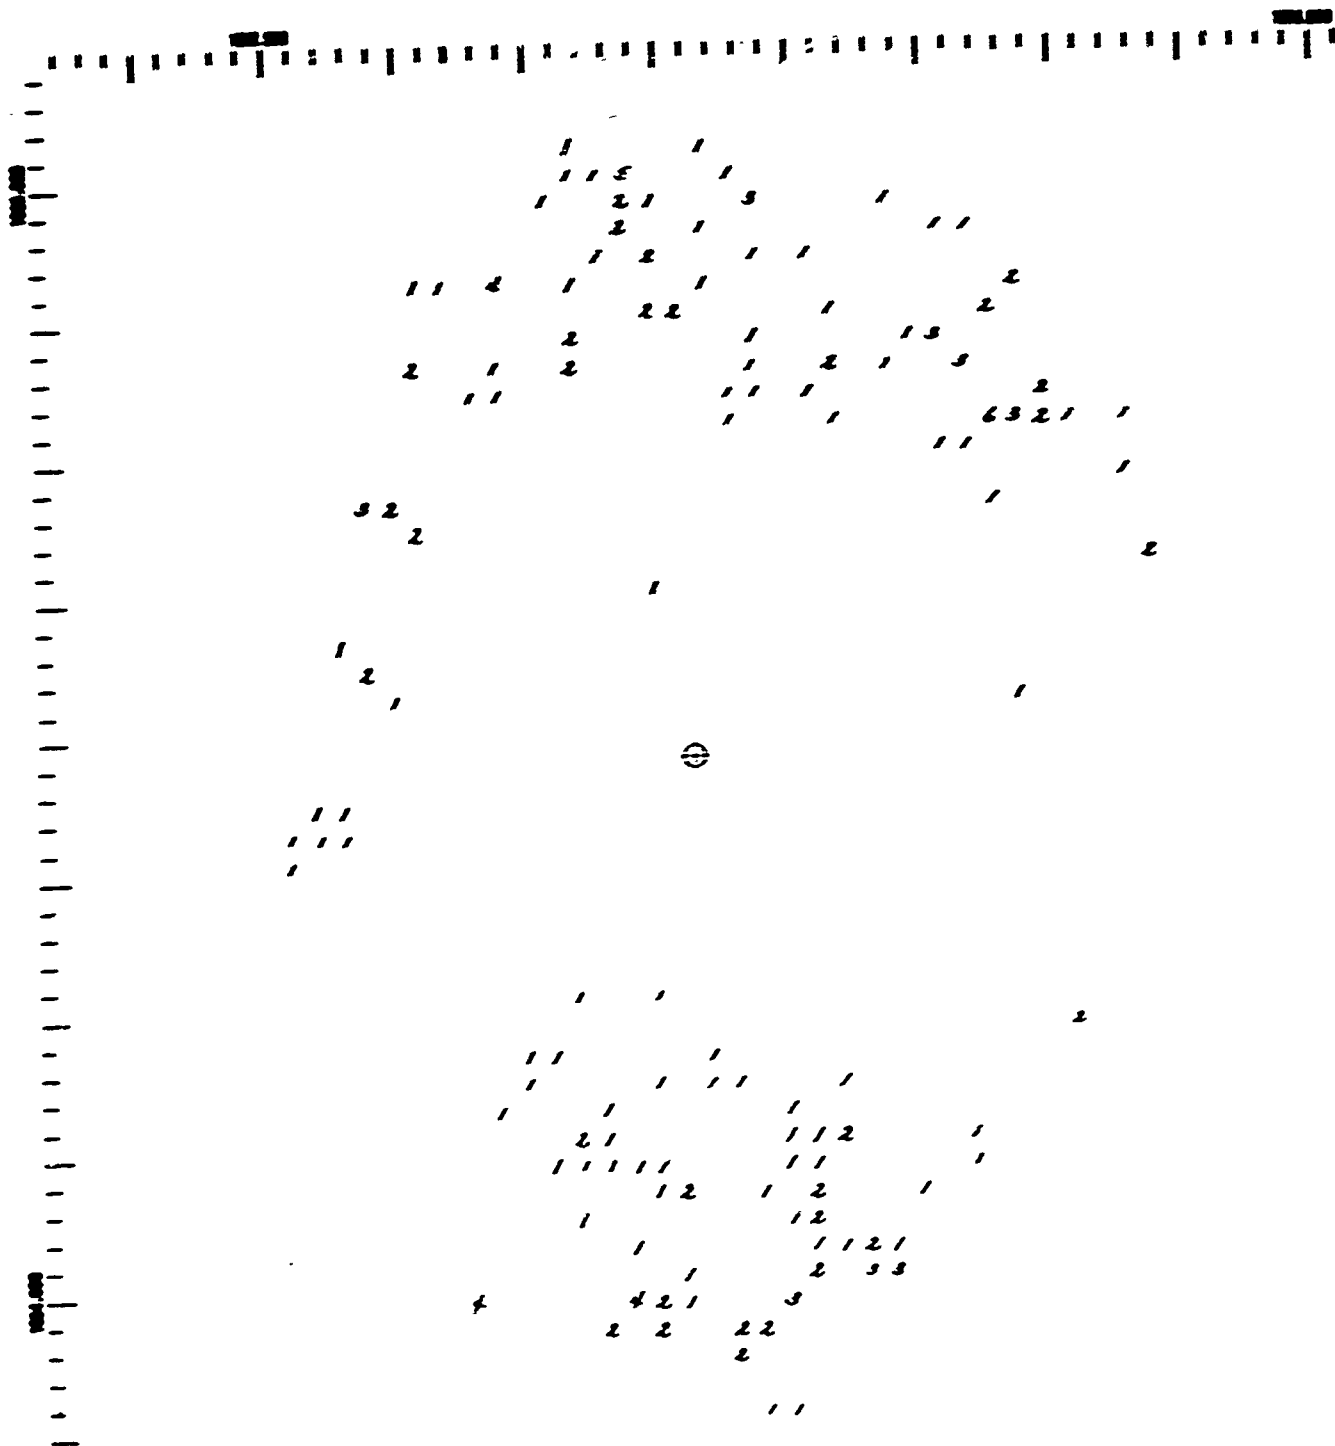
FIG. 25

DISTRIBUTION OF MODERATE FLASH BURNS FOR NAGASAKI  
OUTSIDE UNSHIELDED

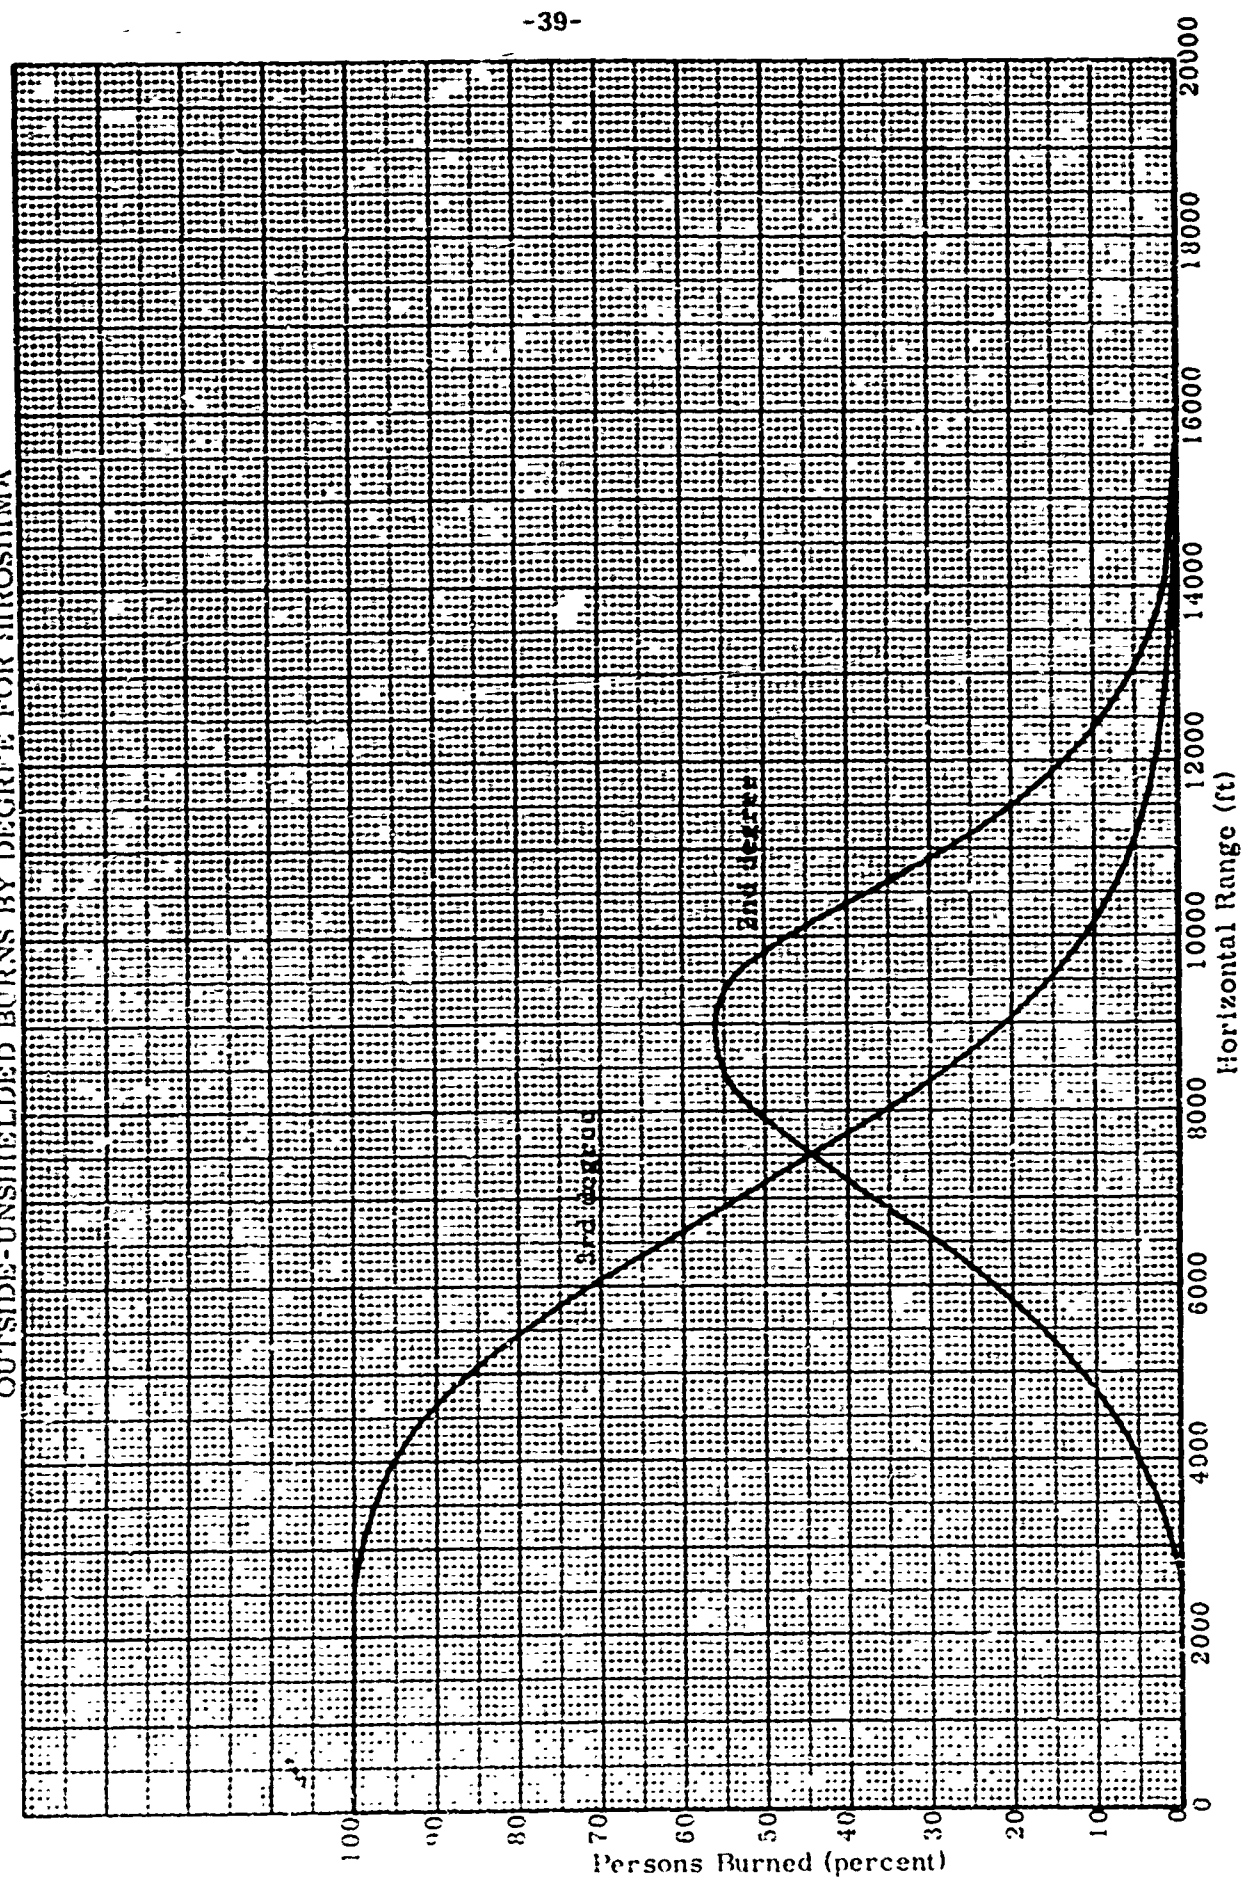
FIG. 2V  
OUTSIDE-UNSHIELDED BURNS BY DEGREE FOR HIROSHIMA

Of the 2,423 persons exposed to direct thermal radiation in Hiroshima, 936 received flash burns of either second or third degree. A total of 475 received second-degree burns, and 491 received third-degree burns. Plots of the percentage of the people in the outside-unshielded category for Hiroshima receiving second- and third-degree burns versus horizontal range are given in Fig. 27.

From the thermal injury curves in Fig. 27 the horizontal range for which 50 percent of the people in Hiroshima received second-degree burns occurred at 9850 feet, and the horizontal range for which 50 percent of the people received third-degree burns occurred at 7190 feet. The slant range for second-degree burns occurred at 3060 meters, and the slant range for third-degree burns occurred at 2260 meters.

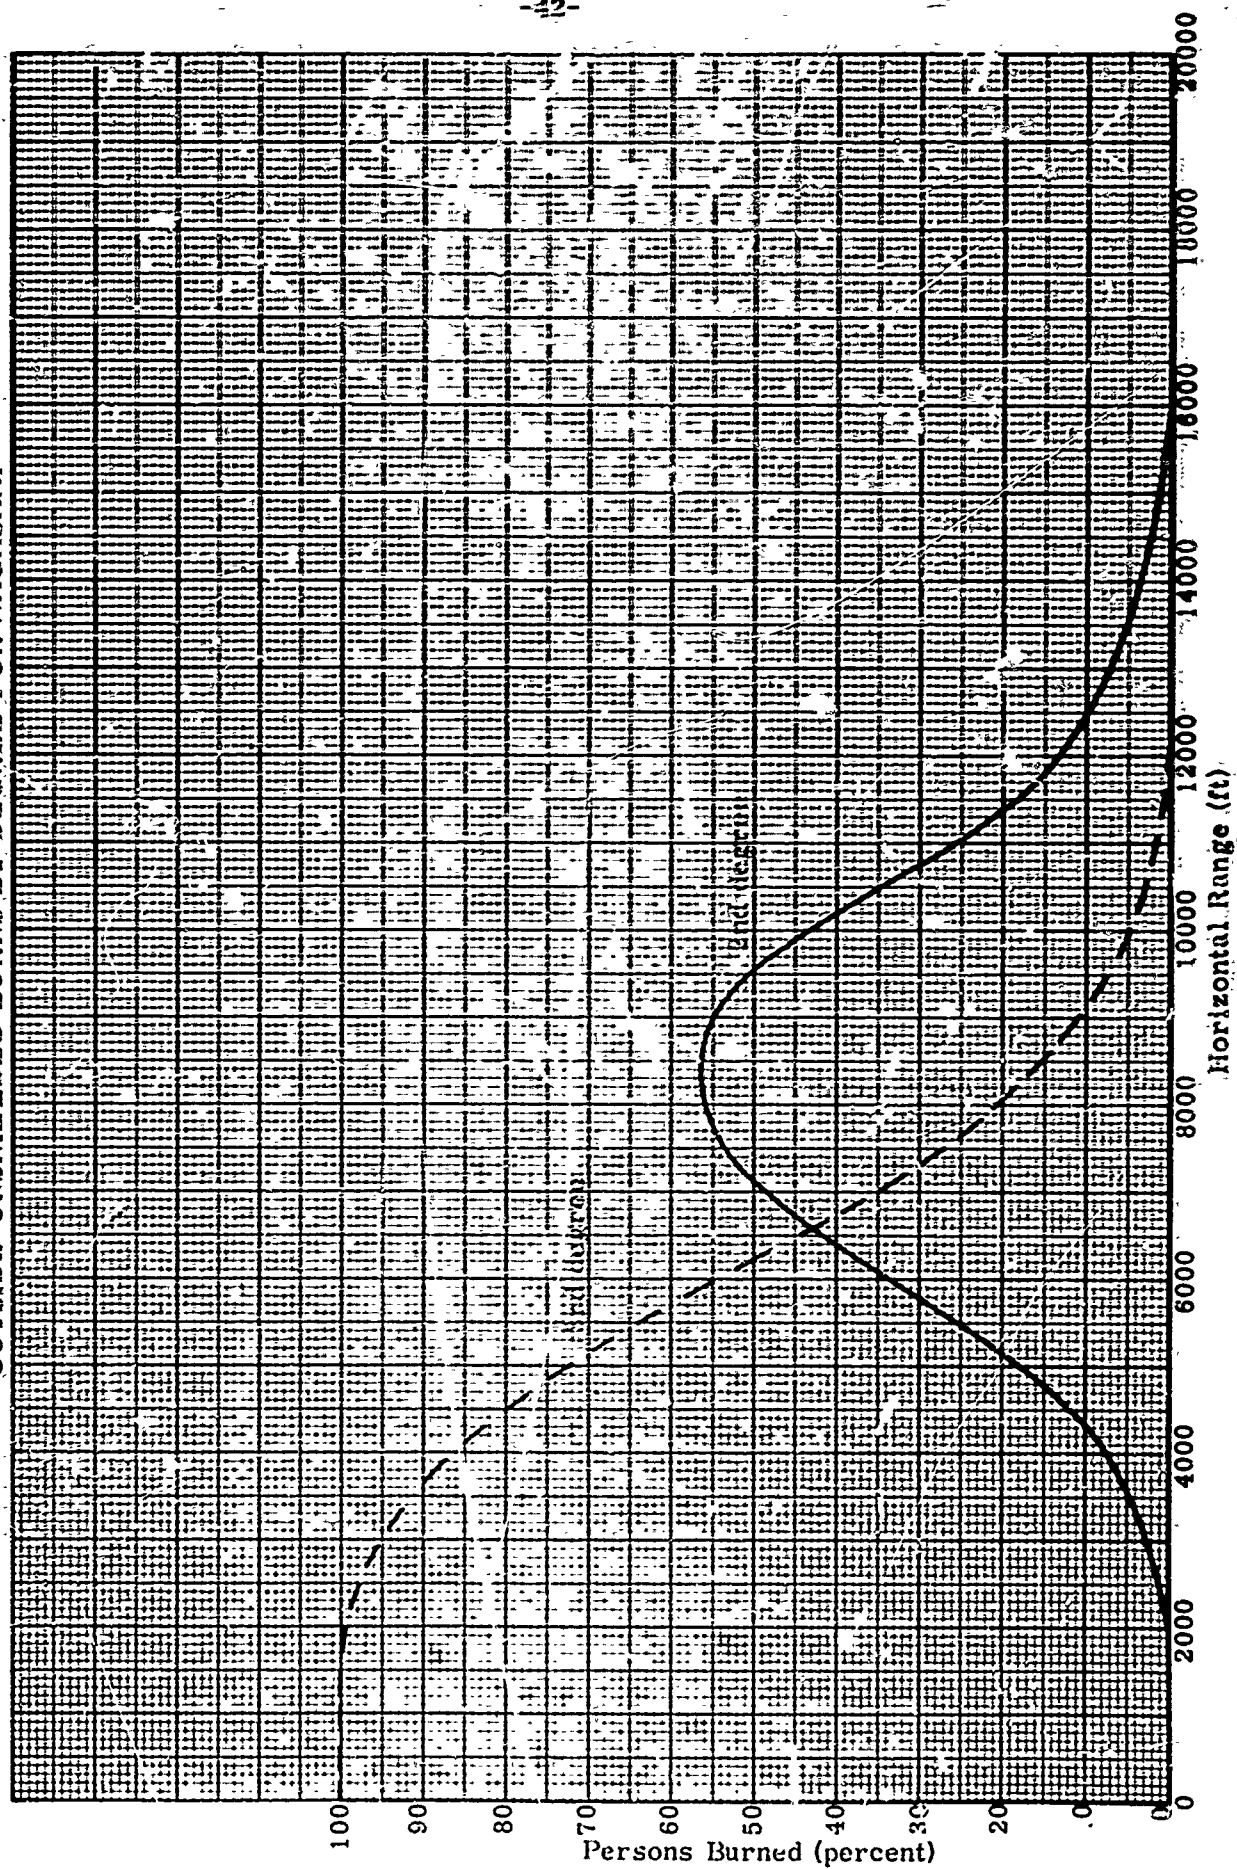
FIG. 28  
OUTSIDE-UNSHIELDED BURNS BY DEGREE FOR NAGASAKI

In Nagasaki a total of 266 persons received either second- or third-degree burns out of the 552 persons who were exposed. Two hundred two had burns of second degree while 64 had burns of third degree. Plots of the percentage of the people in the outside-unshielded category for Nagasaki receiving second- and third-degree burns versus horizontal range are given in Fig. 28.

From these curves the horizontal range for which 50 percent of the people received second-degree burns occurred at 9,550 feet, the estimated horizontal range for which 50 percent of the people received third-degree burns occurred at 6,240 feet. The slant range for which 50 percent of the people received second-degree burns occurred at 2,950 meters. The slant range for third-degree burns was not calculated because of the small sample. The average atmospheric transmissivity  $\bar{T}$  for the above slant range, using a visibility of 10 miles, was 0.636 for the second-degree burn case.

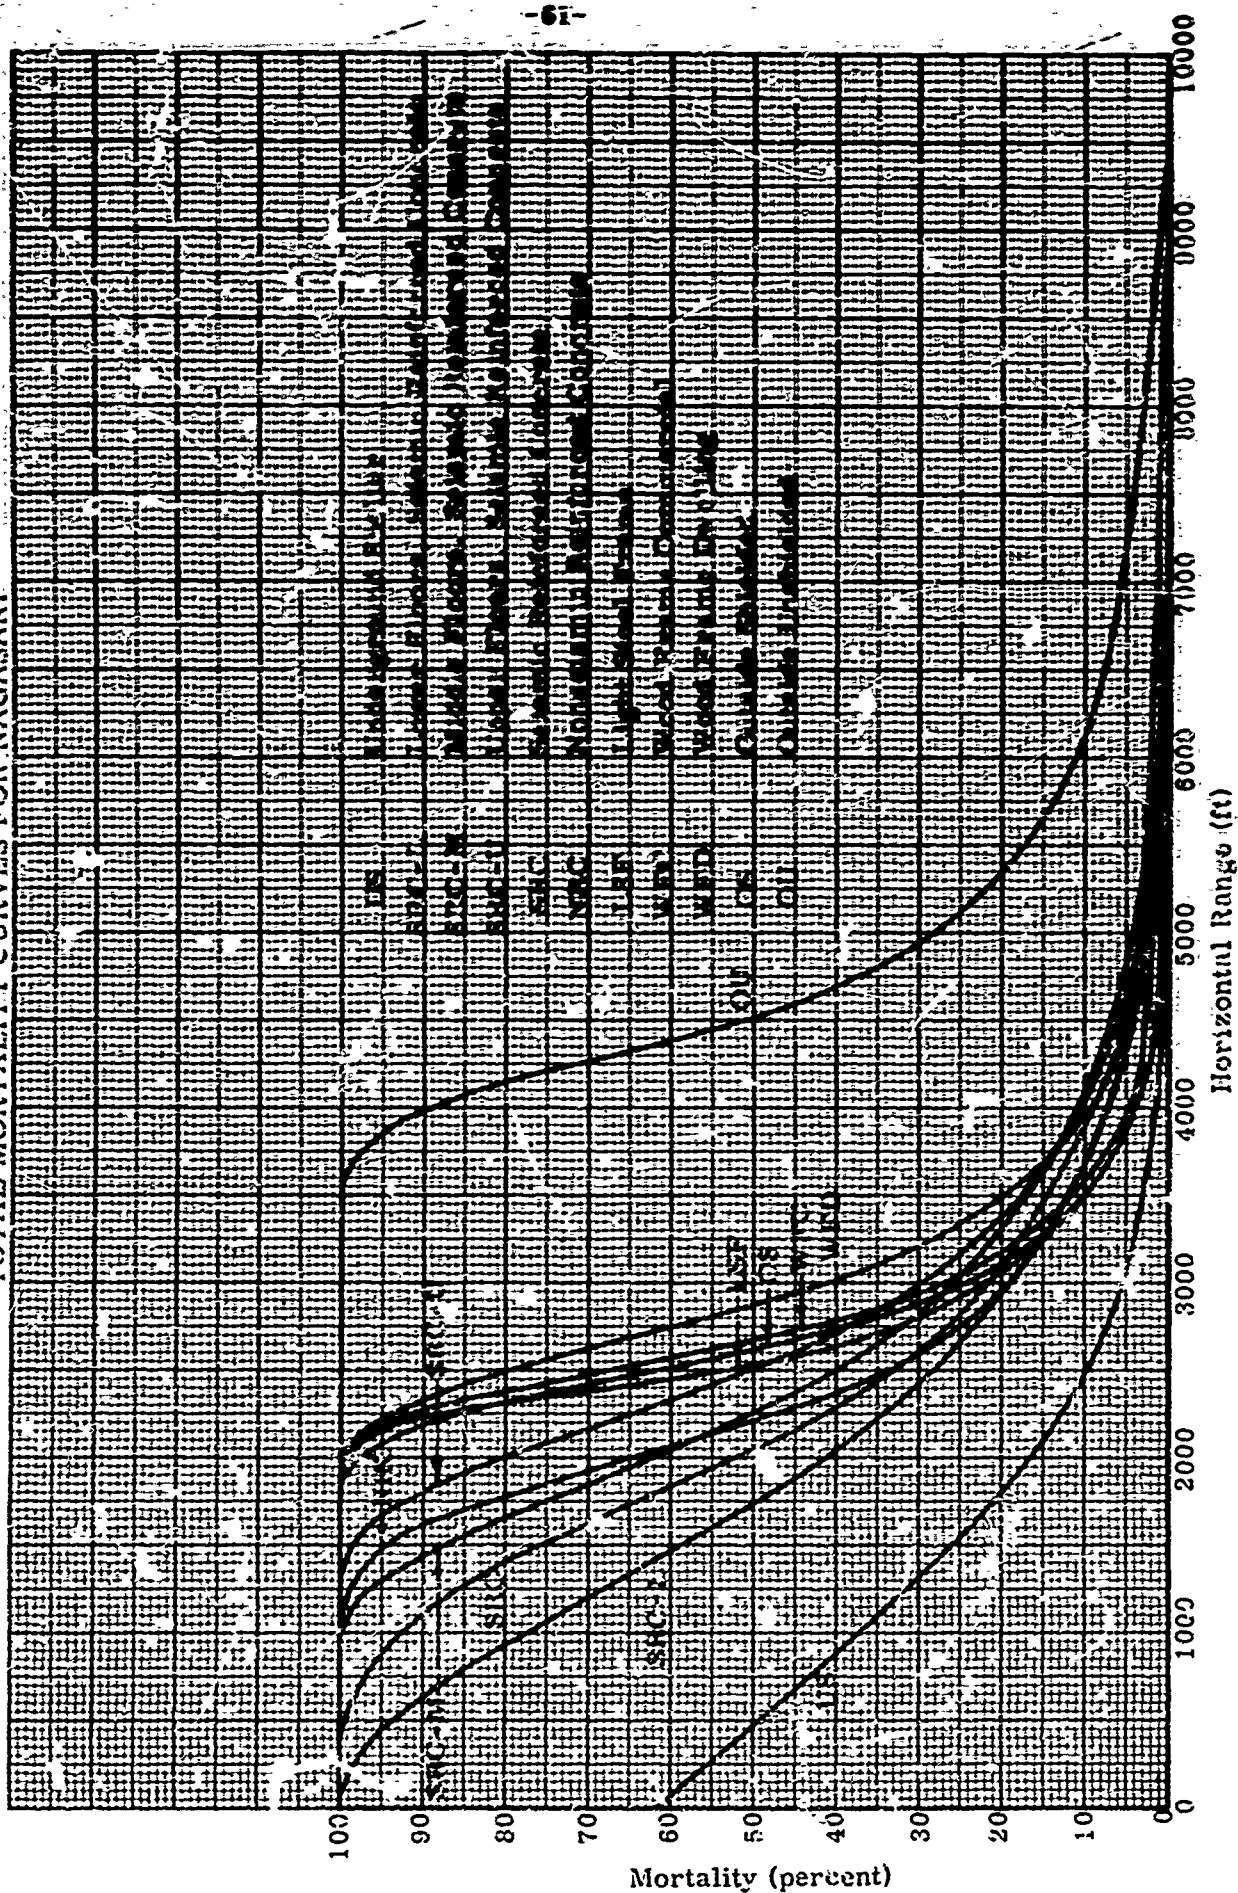
FIG. 36

TOTAL MORTALITY CURVES FOR NAGASAKI
